Pressure cylinders under fire condition[☆]

Summary The presence of pressure cylinders under fire conditions significantly increases the risk rate for the intervening persons. It is considerably problematic to predict the pressure cylinders behaviour during heat exposition, its destruction progress and possible following explosion of the produced air–gas mixture because pressure cylinders and its environment generate a highly complicated dynamic system during an uncontrolled destruction. The large scale tests carried out by the Pilsen Fire and Rescue Department and the Rapid Response Unit of the Czech Republic Police in October 2012 and in May 2014 in the Military area Brdy and in the area of the former Lachema factory in Kaznějov had several objectives, namely, to record, qualify and quantify some of the aspects of an uncontrolled heat destruction procedure of an exposed pressure cylinder in an enclosed space and to qualify and describe the process of a controlled destruction of a pressure cylinder by shooting through it including basic tactical concepts. The article describes the experiments that were carried out.

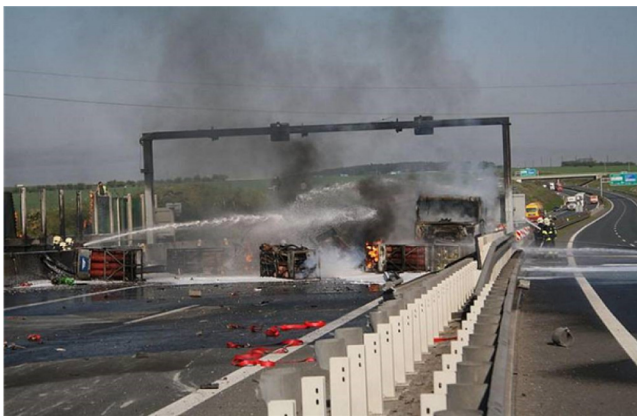
Figure 1 The situation after the traffic accident on the highway D5 during the fire and rescue service intervention.

In 2011 a truck accident occurred at the 78th km of the highway D5 near Plzen in the Czech Republic, see Fig. 1. The truck transporting pressure cylinders overturned after leaving the highway tunnel and its load fell completely off. There was an acetylene leakage because the valves of the acetylene cylinders were damaged. The leaking gas was ignited by the sparks caused by the friction of metal and resinous surface of the road. In the fire condition, some of the cylinders exposed to heat began exploding. During the fire-fighting intervention the possibility to eliminate hazard of more explosions by shooting through other cylinders was evaluated. But in the end the officer in charge did not make the decision to shoot the cylinders. The intervention was later analysed. The analysis leads to two important conclusions. Firstly, the firefighters had not been able to imagine the intensity of the blast effects and the size of the affected area. Secondly, the officer in charge did not make a decision in respect to the shooting of the cylinders because of lack of knowledge and experience with this kind of controlled destruction of pressure cylinders. No doubt, had he decided appropriately, the risk would have been decreased.

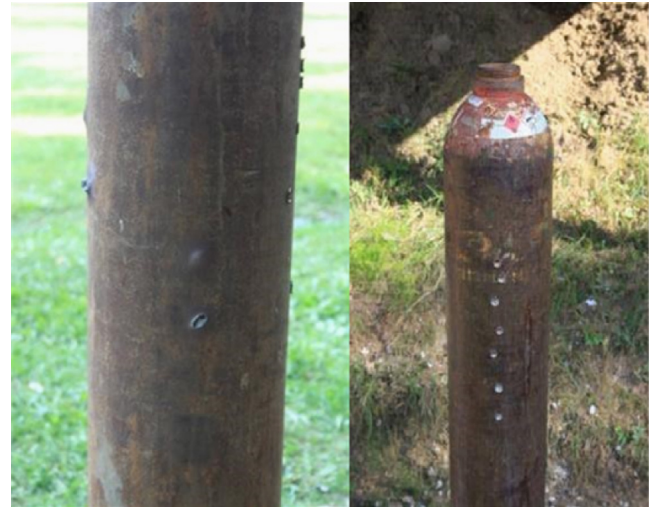
Figures 3 and 4 The situation when the calibre was too large, bullet excessively heavy, and/or ammunition overly effective. In other words, when the parameters of weapon and ammunition were not sufficient.

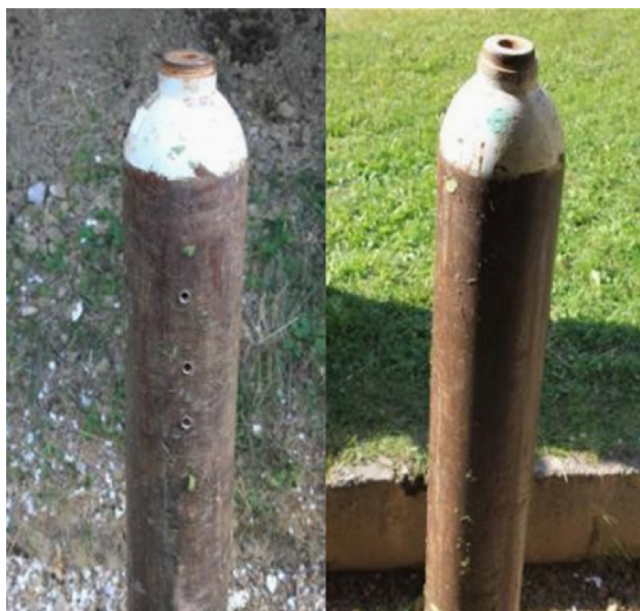
Figures 5 and 6 When the weapons and ammunition are appropriately chosen, the bullet stops inside the cylinder because of its fragmentation.

- the bullet must be stopped inside the cylinder after passing the near wall, fragments must not be formed.

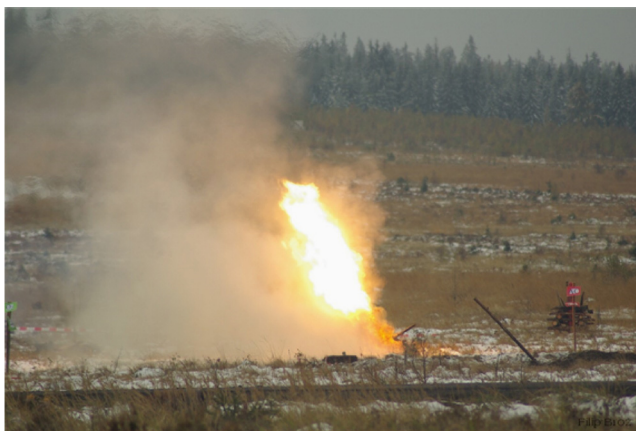
Figure 8 A controlled destruction of a high pressure drawn cylinder via shooting. The cylinder in the picture contained acetylene.

On the basis of the carried out tests several conclusions could be drawn. A significant difference in quality between uncontrolled destruction and controlled destruction via shooting was observed ([Figs. 8 and 9](#)). Later, when high-speed camera records were closely examined, it was clearly perceptible that the response of pressure cylinder to the impact of projectile was closely related to the pressure bottle content. Moreover, intense fragmentation was perceived when oxygen or hydrogen cylinders were blowing up, e.g. a lot of primary fragments were formed. Unlike oxygen and hydrogen pressure bottles, the cylinders filled with liquefied propane or acetylene formed two or three big primary fragments during the destruction ([Denkstein and Kusák, 1995](#)).

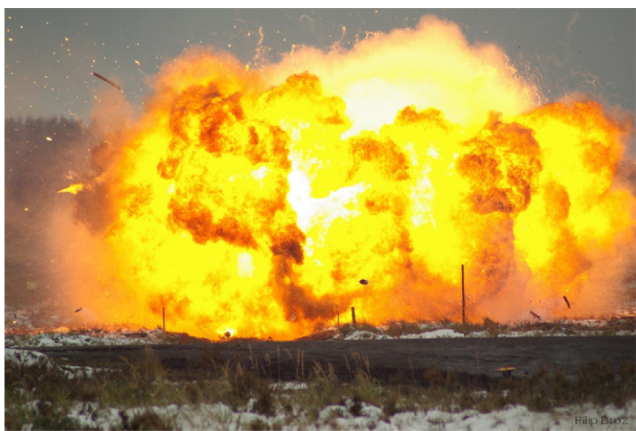
Figure 9 An uncontrolled destruction of a high pressure drawn cylinder. The cylinder in the picture contained acetylene.

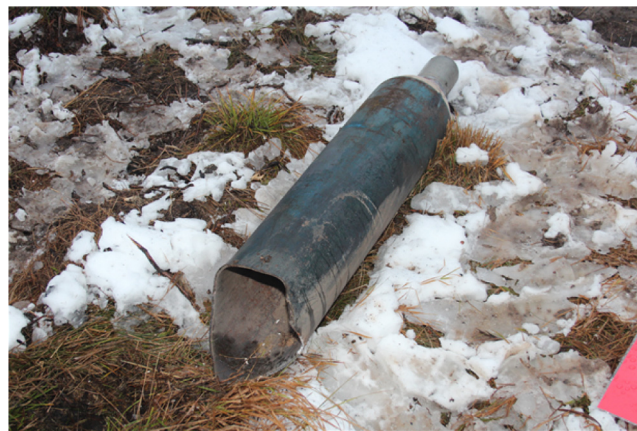
Figure 10 The fragmentation of a high pressure drawn cylinder. The cylinder in the picture contained oxygen.

Contrary to the original assumption, the dramatic progression of an uncontrolled destruction of the cylinders with oxygen was remarkable. This process was connected with the formation of many small primary fragments ([Fig. 10](#)). In addition to the above-mentioned, the violent reactive movement of the oxygen pressure bottle when stricken by a bullet was a surprise.

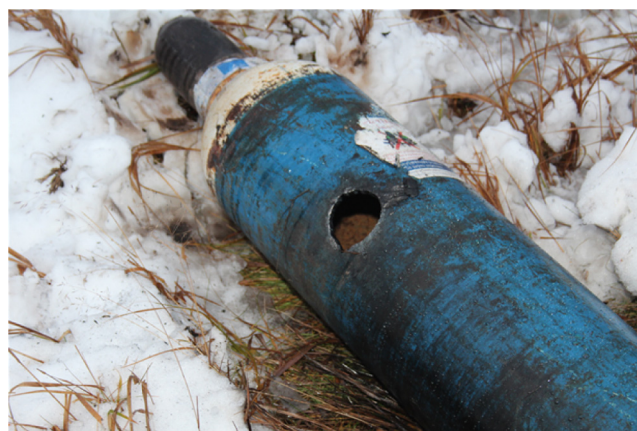
Figure 11 The penetration of a high pressure drawn cylinder. The cylinder in the picture contained oxygen.

The bullet was deformed and some changes in the structure of the steel took place after the impact on the pressure cylinder surface. This process is caused by temperatures

higher than 1550°C when a shooting cavity arises. The shooting cavity becomes an opening through which the over-pressurised oxygen is ventilated. In the atmosphere of high density oxygen the shooting cavity wall melts due to violent oxidation. A ten times wider hole than the original diameter of the projectile is the result of this process (Fig. 11).

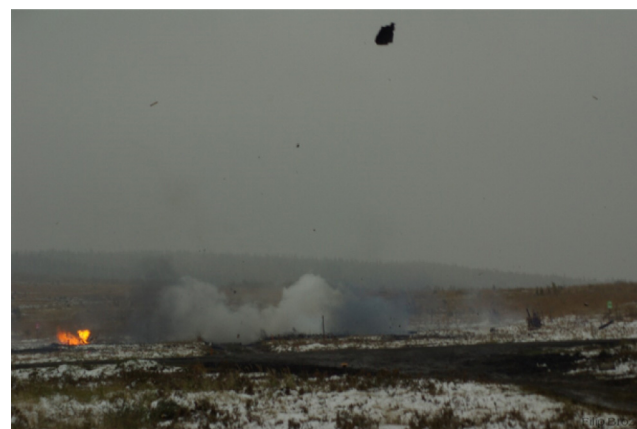
Figure 12 The situation after BLEVE. A flying large fragment is clearly visible.

An interesting example of BLEVE as a result of an uncontrolled destruction of a low-pressure welding cylinder with propane was seen on the first day of tests. The mechanical explosion had been so strong that a 25 kg heavy fragment was found in the distance of over 160 m. As a consequence of cold weather (it was 4°C), and high humidity, the propane mists arising due to a violent leakage after the rupture of the pressure bottle was not ignited (Fig. 12). This mixture of propane

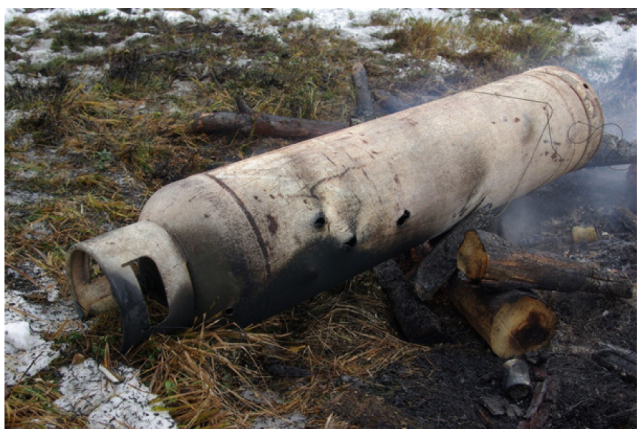
Figure 13 The situation after a controlled destruction of a low pressure welded cylinder. The cylinders in the picture contained liquefied propane.

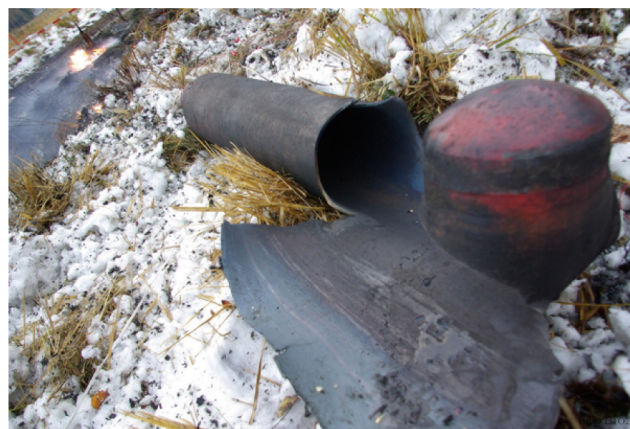
Figure 14 The situation after an uncontrolled destruction of a high pressure drawn cylinder. The cylinders in the picture contained hydrogen. A tendency to fragment is obvious.

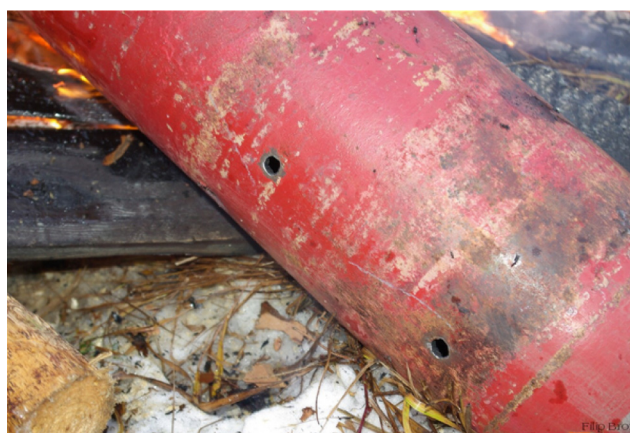
Figure 15 The situation after a controlled destruction of cylinders. The cylinders in the picture contained hydrogen.

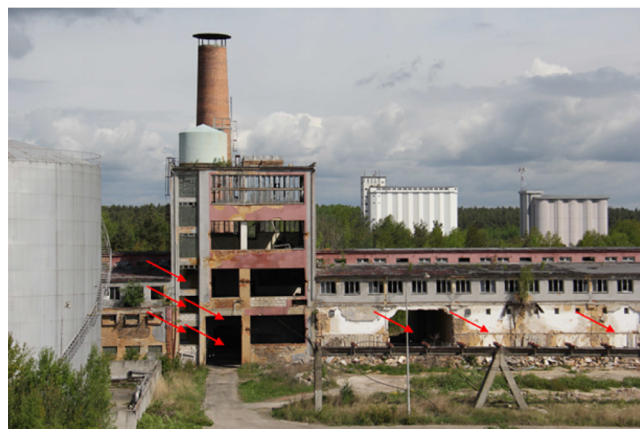
Figure 17 View of the building of the former fermentation where experiments took place. The places where the cylinders were located are marked by arrows.

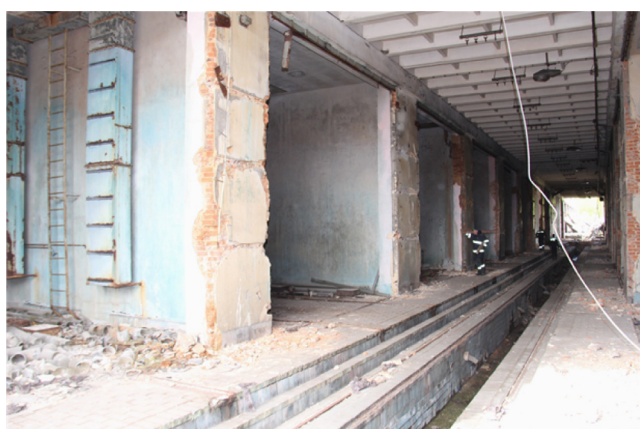
Figure 18 The siding corridor and individual cubicles. The dimensions of a cubicle were (7×13) m. The height of the ceiling was 6 m.

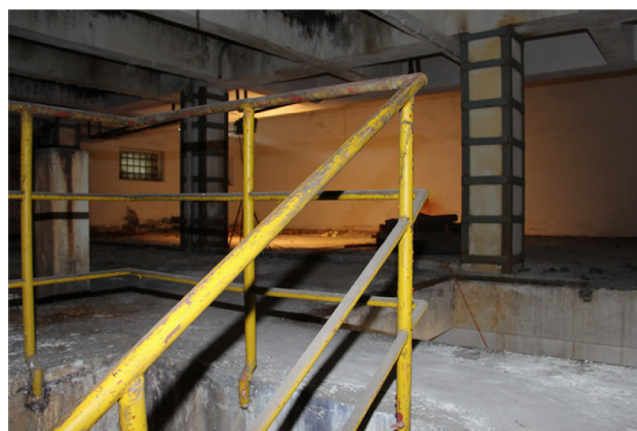
Figure 19 An enclosed room in the technological part where parameters were measured during the explosion of the pressure cylinder with acetylene. The dimensions of the room were (14×13) m, the ceiling height was 3 m and 4.2 m.

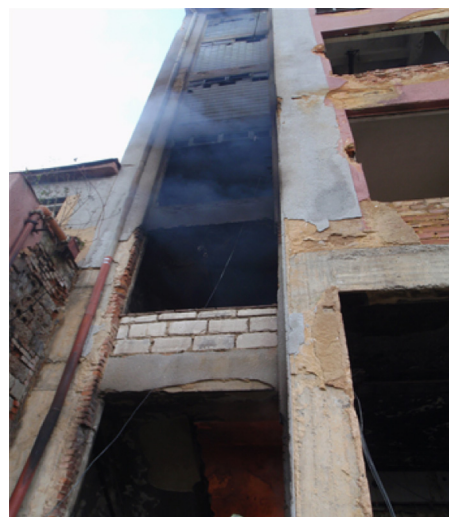
Figure 20 The staircase where a controlled destruction took place. The dimensions of the staircase were (2.9×5) m, the height 21.3 m.

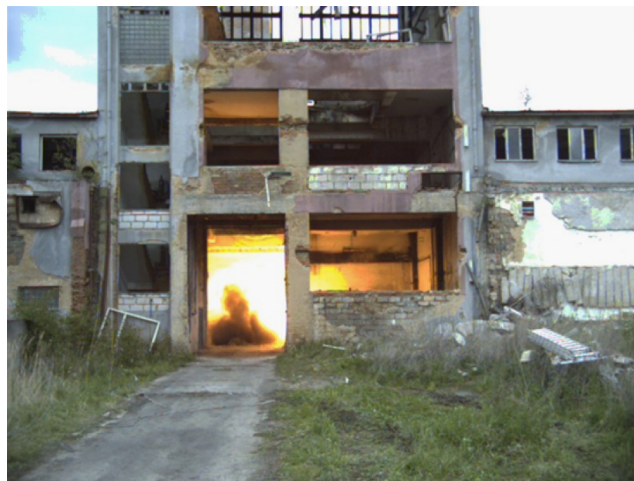
**Figure 21** Deflagration of the air mixture with acetylene.

Uncontrolled destruction of cylinders with acetylene occurred at about 7 min after igniting the woodpile with an electric igniter (see Figs. 21–23). The rupture that occurred in the cylinders, was throughout its length, see Fig. 24.

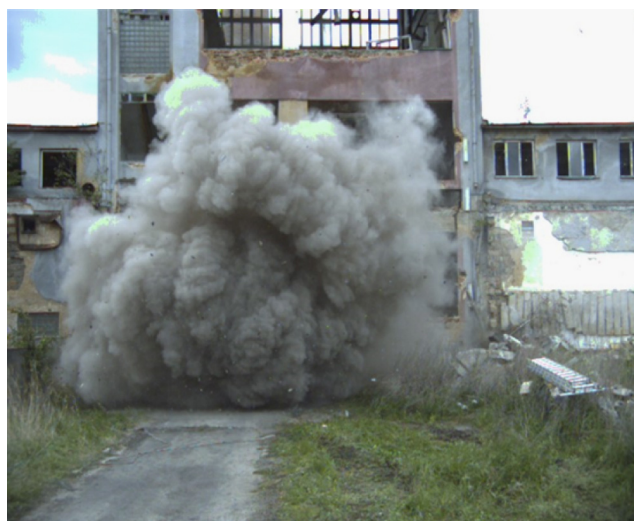
**Figure 22** The fragmentation during the explosion of cylinders with acetylene.

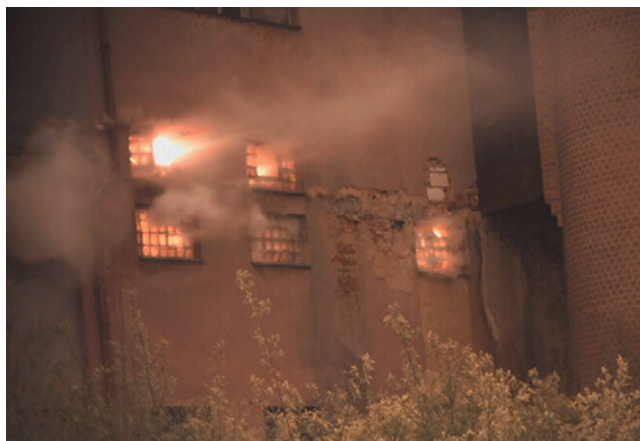
Figure 23 The outside view of the room during the explosion of pressure cylinders with acetylene.

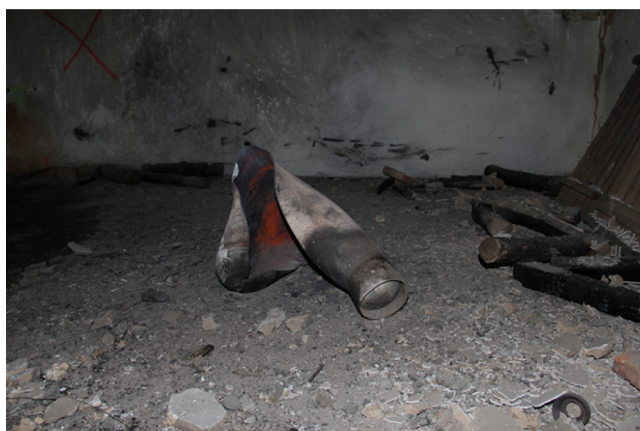
Figure 24 A pressure cylinder after destruction.

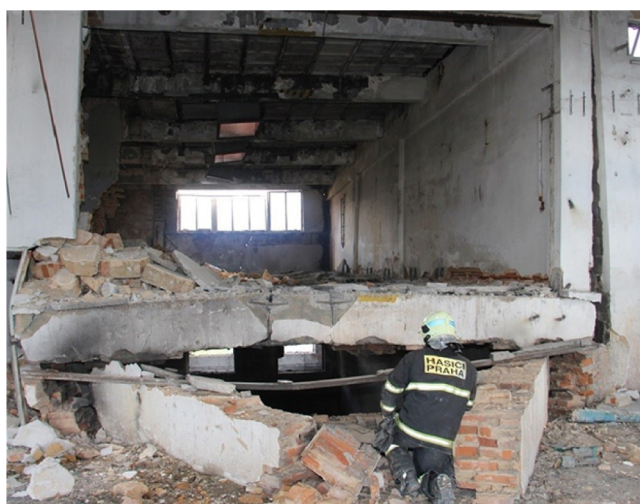
Figure 25 The ceiling and front wall after the explosion of cylinders with acetylene-view from the outside.

The explosion of the cylinder had intensive destructive effects (documented in Figs. 25 and 26). The ceiling slab

was lifted and partial destruction of the structures occurred in higher levels of the object, and as a consequence of it girders broke and crushed concrete spilled. The construction of the three perimeter walls of full bricks was bulging out of the room in the direction of the pressure wave.

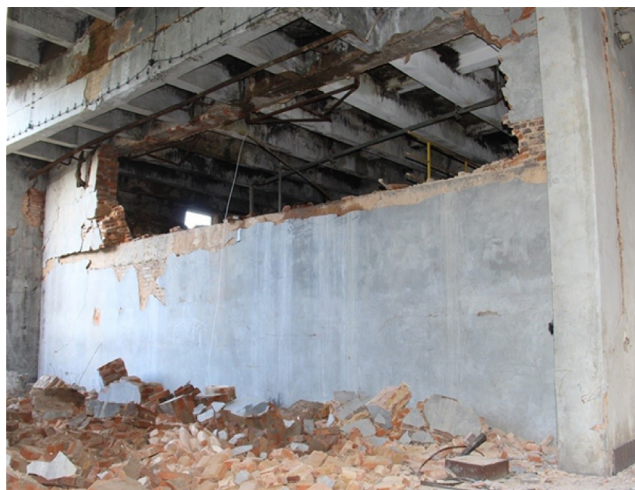
Figure 26 The left side of the room after the explosion of cylinders with acetylene – view from the outside.

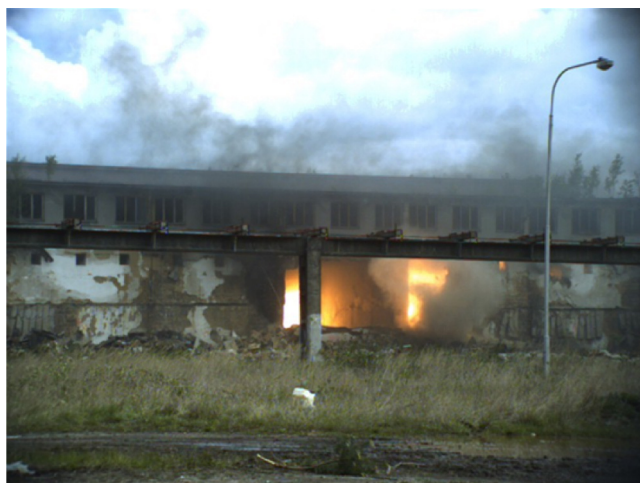
Figure 29 The progress of an explosion of pressure cylinder with acetylene in one of the cubicles.

interval between explosiveness and low initial energy of the mixture acetylene-air. The mixture of acetylene with air started to burn even during the expansion of the gas after the cylinder burst, when the significant surplus of acetylene was in the mixture (The Czech Association of the Industrial Gasses). The captured records show, that the burning mixture filled as cubicle, where the cylinder was placed as the opposite cubicle and then spread through the corridor in the longitudinal direction. Then the mixture spread through the openings in the peripheral construction and ceiling construction to the second floor, respectively out of the object, where the mixture burnt out. The different speed of burnout of mixture inside and outside indicates that the combustion should not be kinetic character, but there was present a significant influence of diffusion processes (Figs. 29–31).

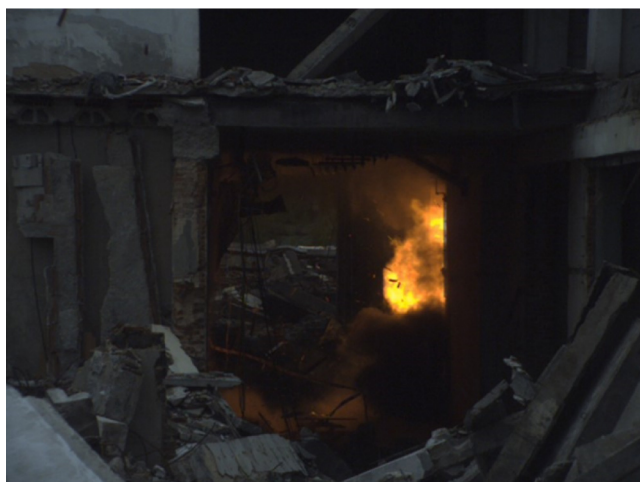
Figure 30 The process of the explosion of the cylinder with acetylene in one of the cubicles in the initial phase. Expanding gas followed by the zone of combustion is evident.

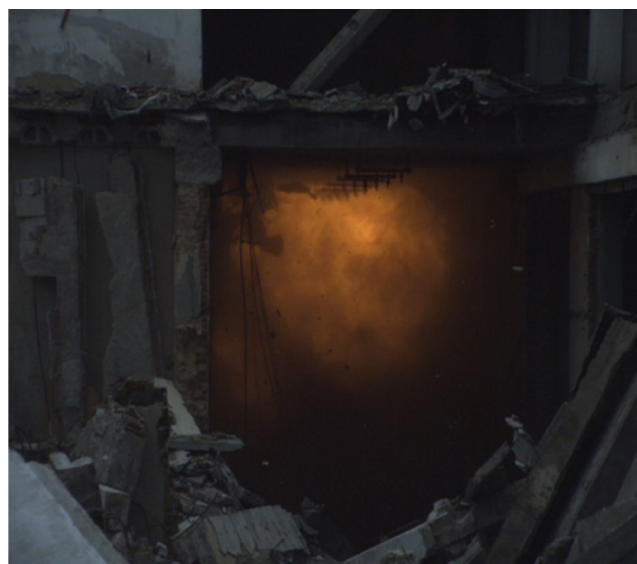
Figure 31 The process of the explosion of the pressure cylinder with acetylene in one of the cubicles in the later phase. Turbulent vortex is visible in the upper part of the corridor.

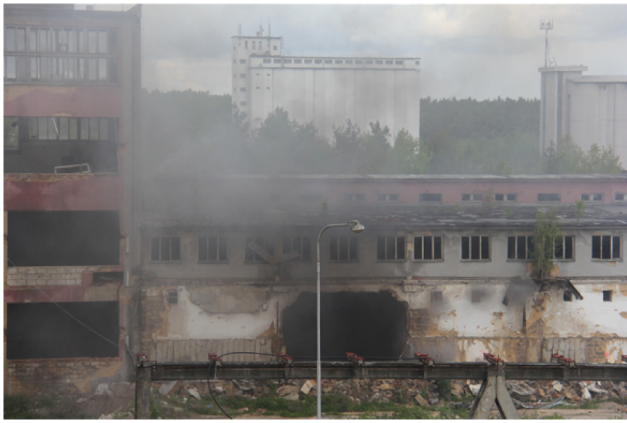
Figure 32 The process of the explosion of the cylinder with propane in one of the cubicles in the phase of expansion. The leaking propane is visible in the holes of the wall at the bottom right.

separated. This process is apparently related to rapid gas expansion due to BLEVE and narrow interval between explosiveness and the high value of initial energy of the mixture propane-air. The mixture of propane and air began to burn after the expansion of propane has finished. The record from the interior shows that the pile was spreading – of its larger part – and in the atmosphere with significant excess of the propane, the interruption of the flame combustion and combustion of their remains happened. A flame of a backup source, i.e. burning oil and wood in a tin bath located at the edges of the cloud of the mixture propane-air, was the initial source. The captured records show that the burning mixture not only filled the cubicle, where the cylinder was placed, but also the opposite cubicle and then spread through the corridor in the longitudinal direction. The mixture spread through the openings in the peripheral construction and through the ceiling construction to the second floor and out, respectively. The mixture burnt out mainly by the deflagration way and the burning showed significant kinetic character. The delay in burnout of gaseous residues inside the building was also observed in this case although to a much lesser extent. It is possible to believe that the combustion had partially diffuse character in the end (Figs. 32 and 33).

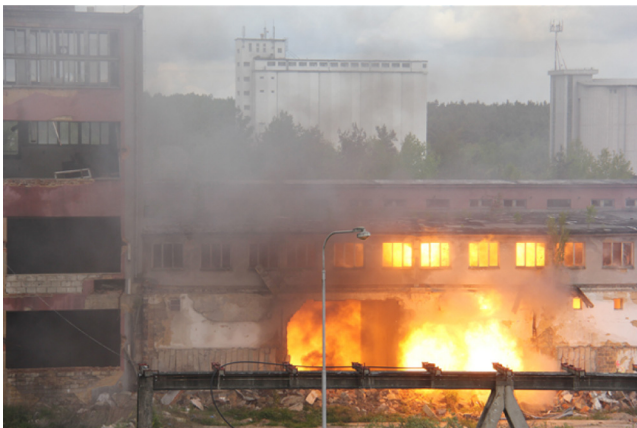
Figure 33 The process of the explosion of the cylinder with propane in the moment when the explosion reached the maximal parameters.

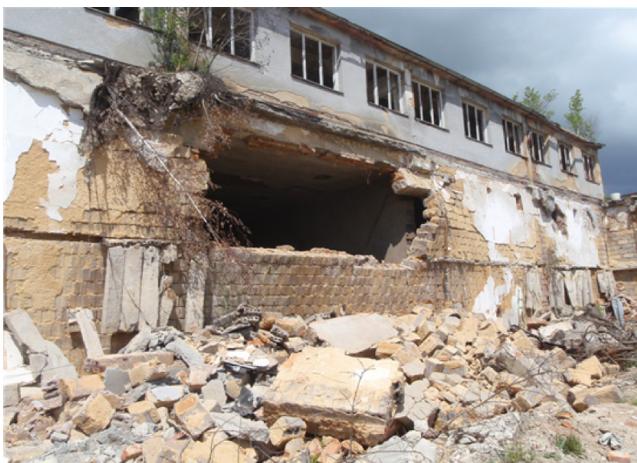
Figure 34 The destruction of the peripheral wall after the explosion of the cylinder with acetylene. The zone of debris is visible below the wall.

Despite the fact, that the explosion was vented, some structures could not resist its effect. After the explosion of the cylinder with acetylene the peripheral construction was damaged in its upper part at a height equivalent to about half the height of the construction and in their lower parts the peripheral construction was torn from the supporting structures. A zone of debris was visible on the outer side of the object and formed a band with a width of 8 m and a length of 9 m (Fig. 34). The damage of the peripheral construction showed progressive process in a connection with the stress caused by other explosions of acetylene and LPG. However, damage showed downward trend due to the increase of the total area of the exhaust walls. The cracks

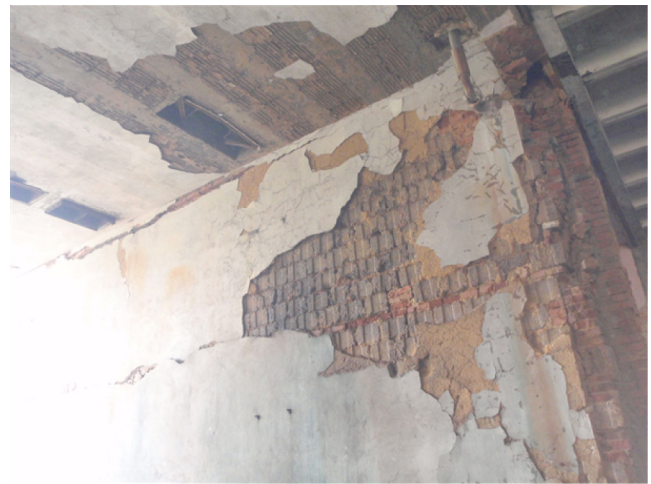
Figure 35 The failure of the internal supporting wall and column after the explosion of the cylinder with acetylene.

in the masonry were visible on the supporting structures that were mounted transversely at a height corresponding to approximately half of a height of the structure. A violation of a binding between the ceiling and the walls could be a possible explanation and it is due to the movement of ceiling construction upwards.

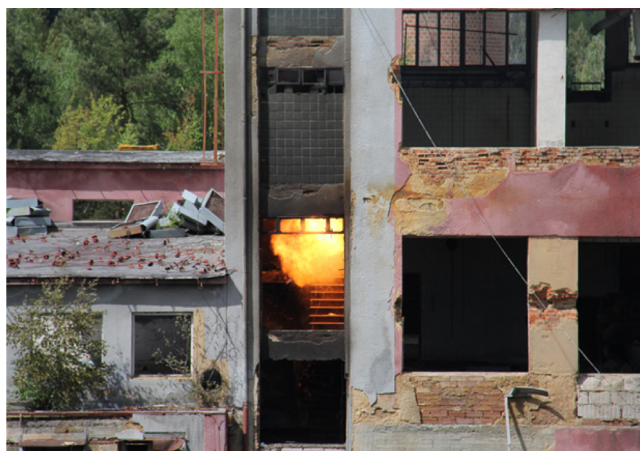
Figure 36 The controlled destruction of the cylinder with acetylene.

behavior in the inner space. Acetylene showed intensive heat treatment but in a relatively small area, while the cylinder was stable (Fig. 36).

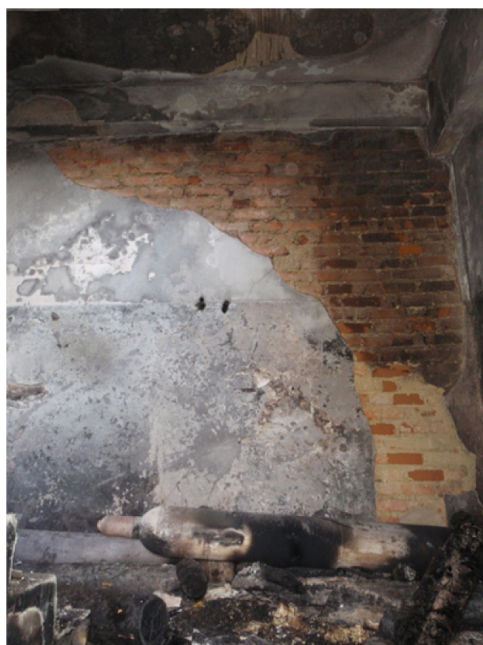
Figure 37 The situation after the controlled destruction of cylinders. The cylinders on the picture contained acetylene and oxygen. The subsiding plaster due to the heat treatment is visible in the background.
